Facility Conditions

Fire Station

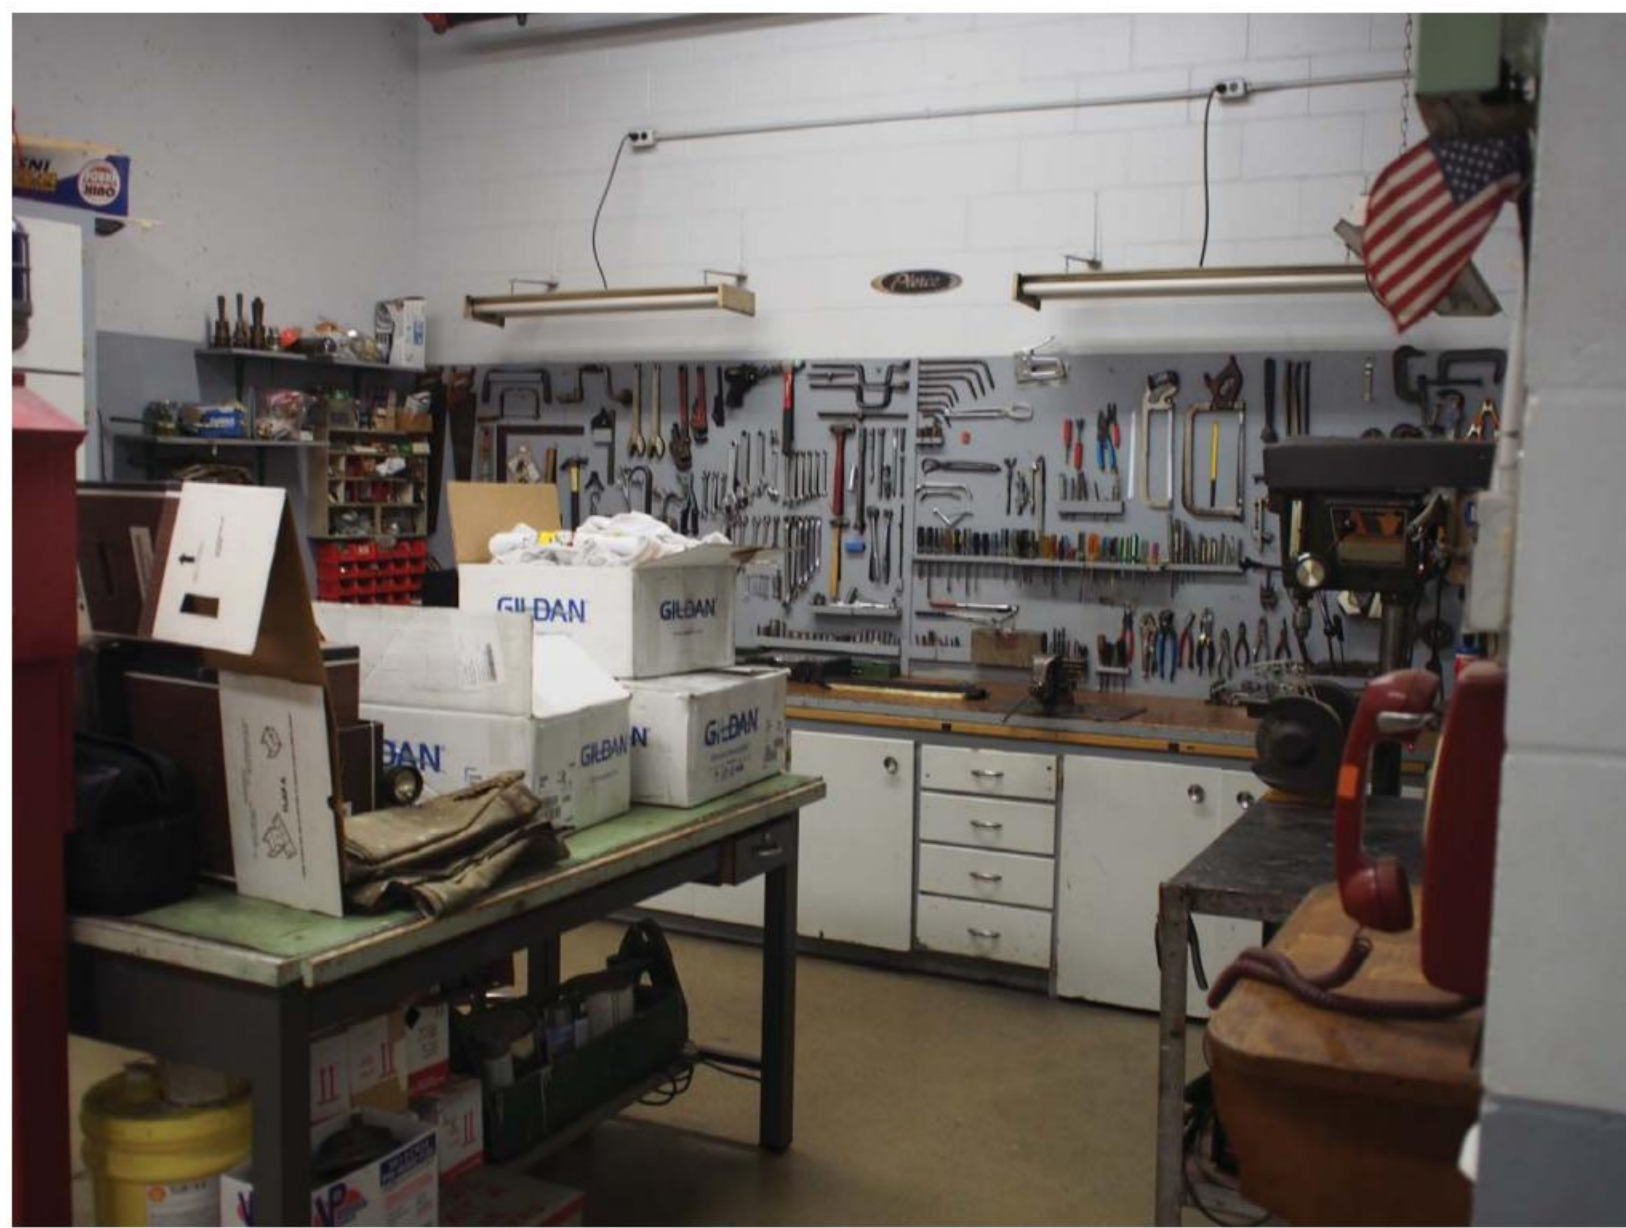
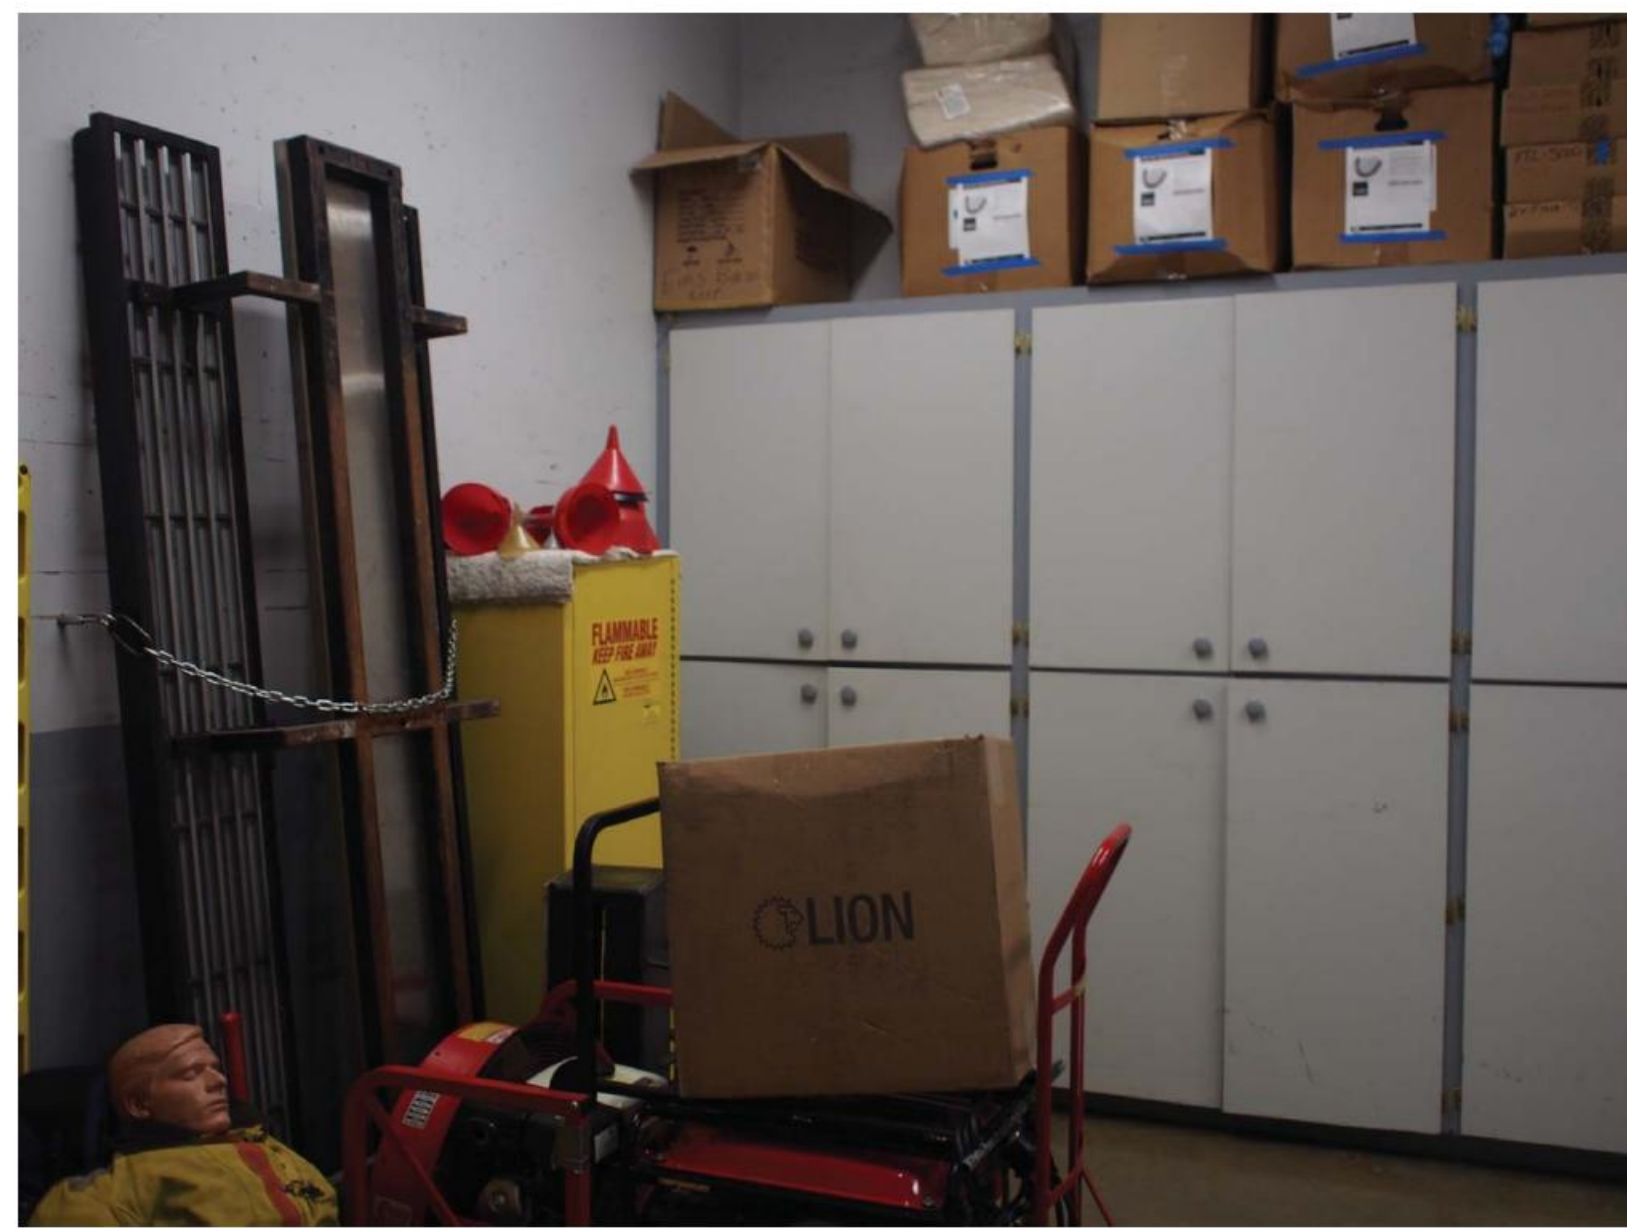
- Apparatus bay trench drains discharge directly into lake
- Exhaust system does not meet current code requirements
- Concrete curb is deteriorating at apparatus bay
- Concrete spalling and cracking at bunker apron
- Corroding steel pipe bollards
- Cracks in retaining wall
- Ponding occurs at roof over bunker, possible leaks
- No provisions for female firefighters
- Apparatus bays are too narrow and unsafe
- Support trucks are located in a separate, unheated building (bunker)
- No protected space for turnout gear
- “Residential” laundry is not adjacent to living spaces
- Offices are not adjacent to apparatus bays
- Fitness area is located inside dorm room, creating odor and noise issues
- No accessible restroom facilities
- Apparatus driveway is constricted by retaining wall and Bunker building

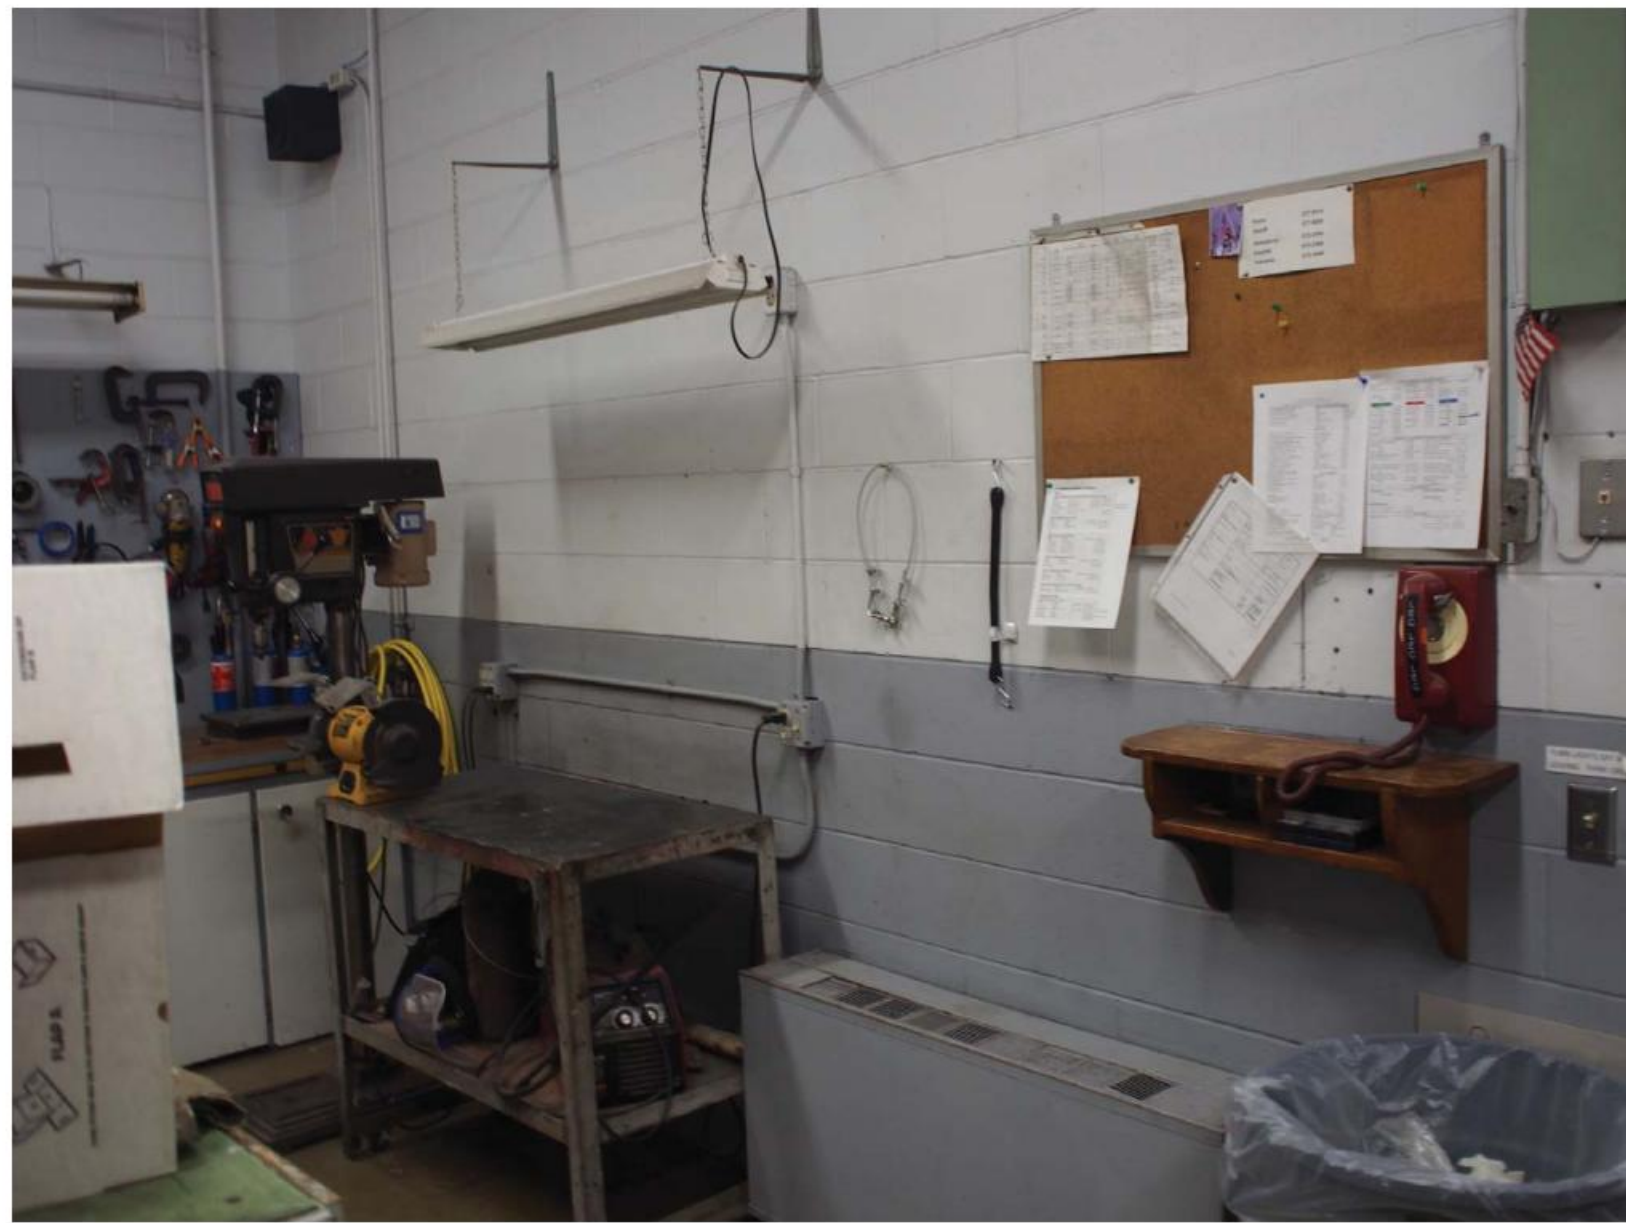
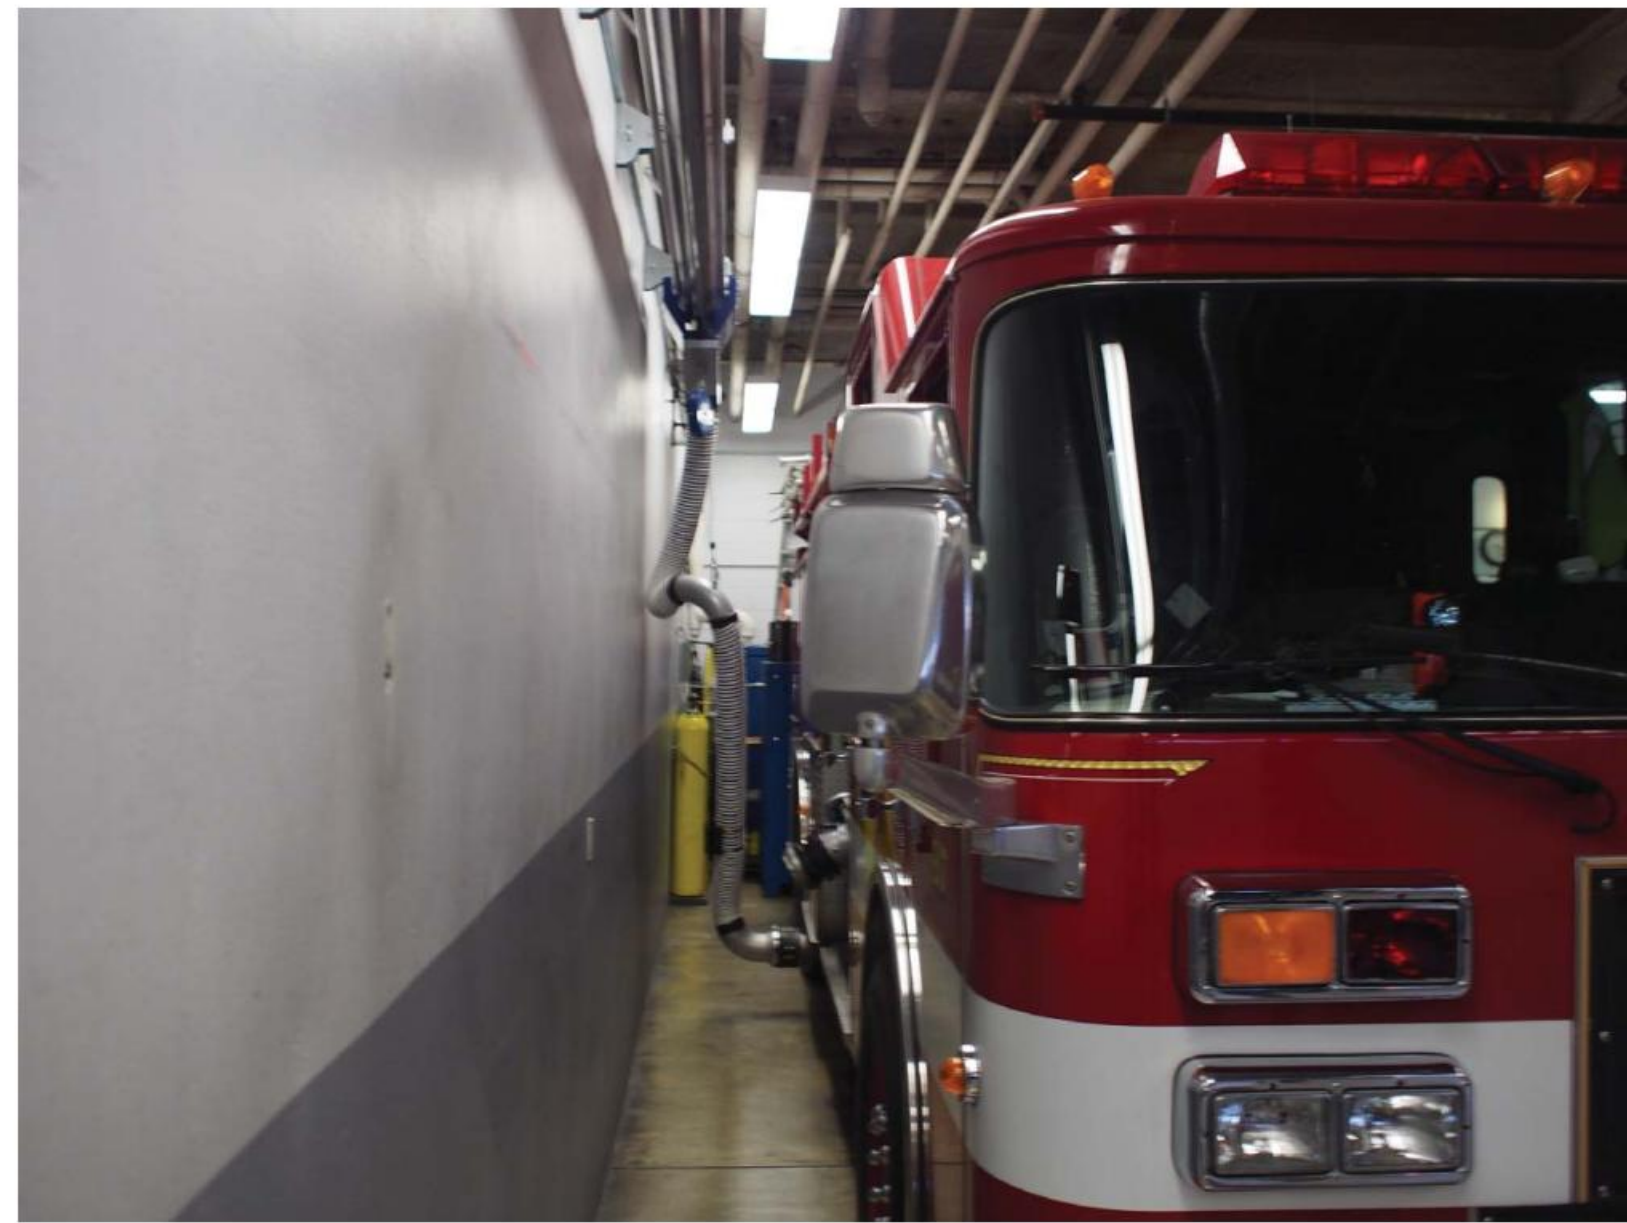
- Does not comply with current Emergency Response Design Requirements
- Lack of required operational space
